American Testing Services, Ltd.
3060 East River Road
Dayton, OH 45439

On-Site Inspection Report

100% of welds on floor of chromic acid waste tank

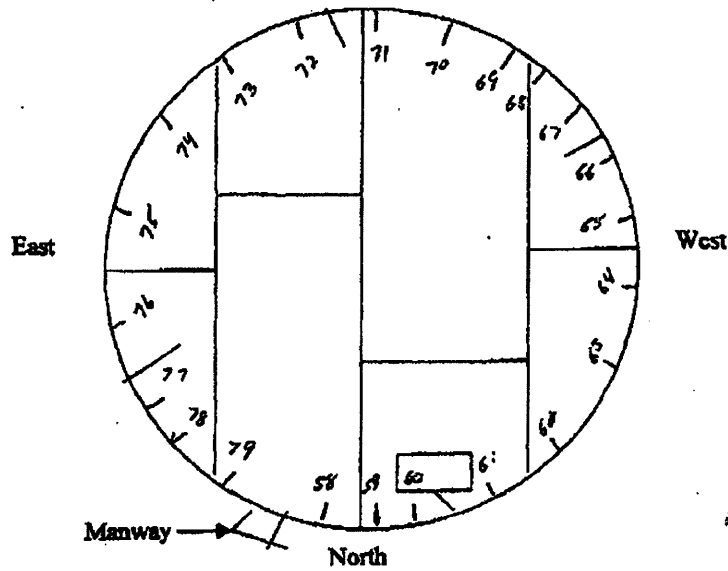
READINGS AND LOCATIONS SIDE WALL
South

*Wall Thickness
Readings.*

Orig. 0.25 in

58.	.253	69.	.255
59.	.254	70.	.267
60.	.252	71.	.264
61.	.248	72.	.266
62.	.246	73.	.268
63.	.249	74.	.264
64.	.252	75.	.262
65.	.255	76.	.259
66.	.260	77.	.248
67.	.260	78.	.255
68.	.256	79.	.253

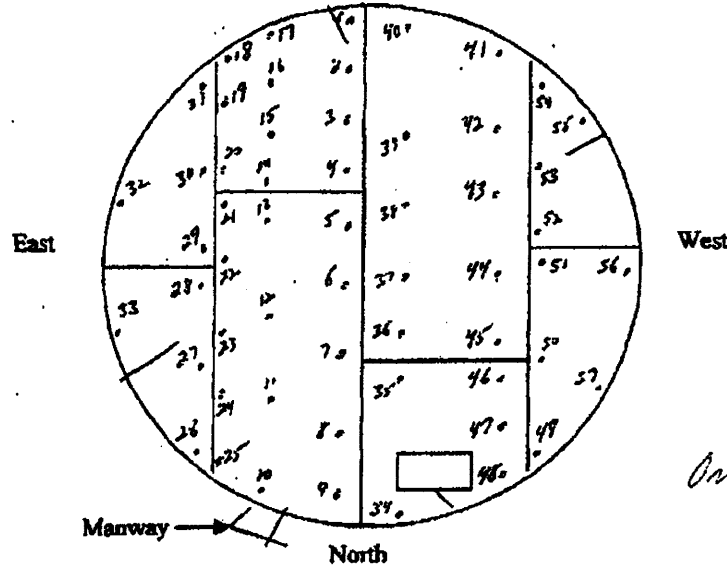
READINGS AND LOCATIONS OF FLOOR
South

100% of welds on floor were inspected and were accepted at time of inspection. There was one crack located on the floor at the south end approx. 1.5" from outside wall and 2" west of the center weld. Crack is approx. 15" long. This tank is rejected.

Floor reading

Orig. - 0.25 in

1. .266	16. .272	31. .264	46. .268
2. .287	17. .280	32. .263	47. .260
3. .283	18. .270	33. .262	48. .270
4. .245	19. .221	34. .244	49. .276
5. .254	20. .243	35. .268	50. .257
6. .246	21. .251	36. .250	51. .256
7. .246	22. .246	37. .258	52. .256
8. .262	23. .239	38. .246	53. .259
9. .257	24. .263	39. .268	54. .258
10. .268	25. .230	40. .253	55. .246
11. .249	26. .264	41. .248	56. .268
12. .239	27. .265	42. .266	57. .263
13. .254	28. .247	43. .257	
14. .239	29. .255	44. .253	
15. .265	30. .255	45. .257
